Fire in automobile spare parts warehouse : Gent, Belgium. October 29,1987

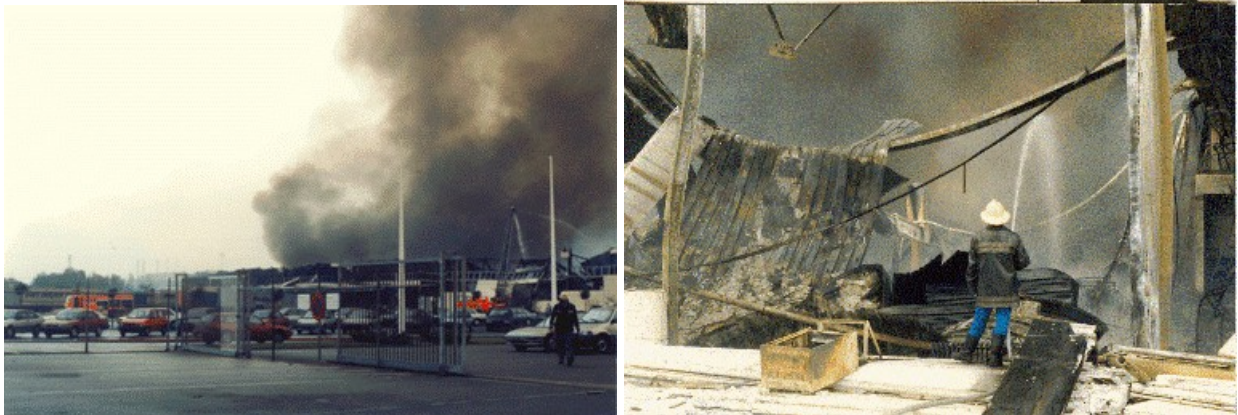
This modern spare parts warehouse of the renowned car manufacturer is located at 10 min. from my home. On that morning, it burned completely down in about 4 hours. The offices, the boiler house and the electrical substation, which were separated from the main building by fire walls, were saved. The people in the building were informed by the fire detection and alarm system and could all leave the building in due time. There were no victims. It took the company about two years to rebuild a new (overprotected) warehouse. During that time the company had to distribute its operations over several rented warehouses in the area.

The origin of the fire remains unknown. A defective lighting fixture in the rack storage has been indicated as the most probable cause. This 31.500 m² large warehouse was used as European spare parts distribution centre of a car manufacturer. Spare parts for all current types were stored here, and orders from garages and stockists were handled here and dispatched within 24 hours. In the building there was 6.7 m high rack storage and order picking areas. Some 160 persons worked in the building.

The building had a steel structure with light concrete external walls. Roof height was 7.5 m. Fire protection consisted of an automatic fire detection system, smoke vents at a ratio of 2 % of the floor area, extinguishers and hand hoses. The plant had a first intervention team, the local fire brigade is a full professional fire brigade at 10 min distance from the plant. The plant had no independent water supply, but is located at +/- 300 m from the sea canal Gent-Terneuzen.
